Manhole Inspection Summary

Manhole # S13C1_004MH

Location Address: **3204 Clarinda Av**

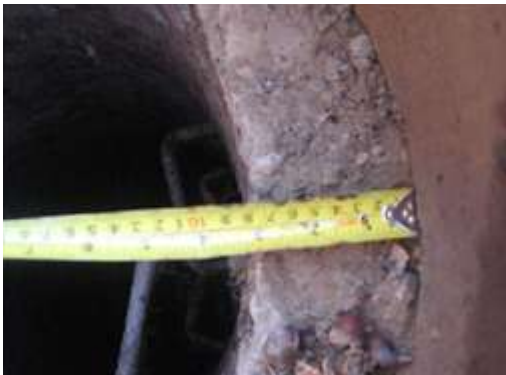
Defect 2

Offset: **3** (in.)

offset 3 inch

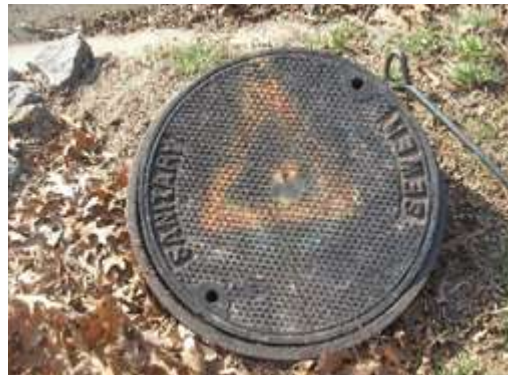
Defect 3

Condition: **Cracked**

Cover cracked

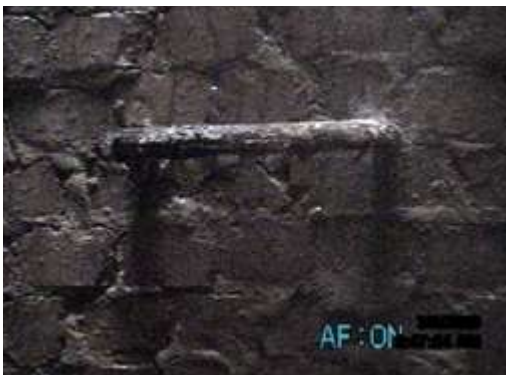
Defect 1

Count: **8** Missing: **0** ☒ Corroded

last step corroded oxidation

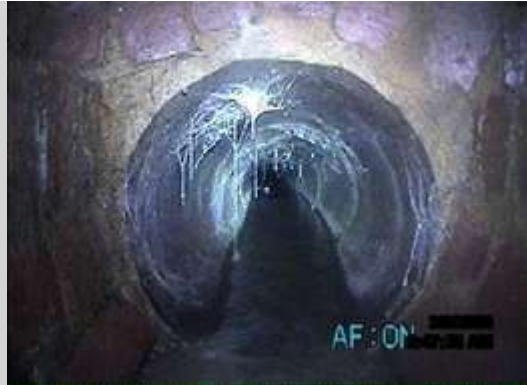
12 O'Clock Outflow

Pipe Height: **8.4** (in.) Rod and Bar (Angled)
Pipe Material: **Clay** ☐ Pipe Lined
Invert Depth: **14.00** (ft.) Flow Characteristics: **Slow**
Deposits: ☒ None ☐ Mud ☐ Sludge ☐ Debris ☐ Grease
Silt Depth: **0** (in.) Deposits Extent:
Infiltration: **None** Pipe Seal Cond: **Sound**

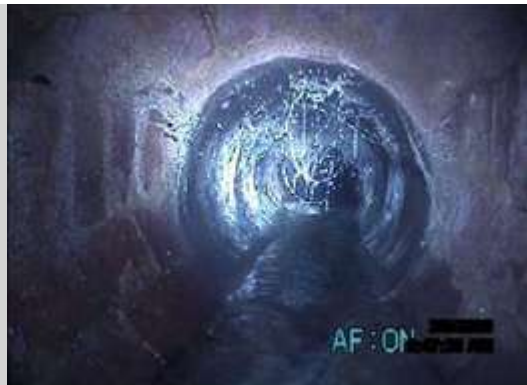
6 O'Clock Inflow

Pipe Height: **8.4** (in.) Rod and Bar (Angled)
Pipe Material: **Clay** ☐ Pipe Lined
Invert Depth: **13.64** (ft.) Flow Characteristics: **Slow**
Deposits: ☒ None ☐ Mud ☐ Sludge ☐ Debris ☐ Grease
Silt Depth: **0** (in.) Deposits Extent:
Infiltration: **None** Pipe Seal Cond: **Sound**
